JOB TITLE
FORMER LANDFILLS/QUARRIES REDHILL, SURREY

DRAWING TITLE
APPROXIMATE MINERAL CAP/RESTORATION SOILS THICKNESS - BEECHFIELD QUARRY

DRAWING TITLE		
CONCEPTUAL SITE MODEL - BEECHFIELD QUARRY (E-W SECTIONS)		
STATUS		
FINAL		
DRAWN BY	SIGNATURE	DATE
AJA		29/05/2013
APPROVED	SIGNATURE	DATE
KL		29/05/2013
SCALE	NOT_TO_SCALE	DRG No.
		20096-E-13A

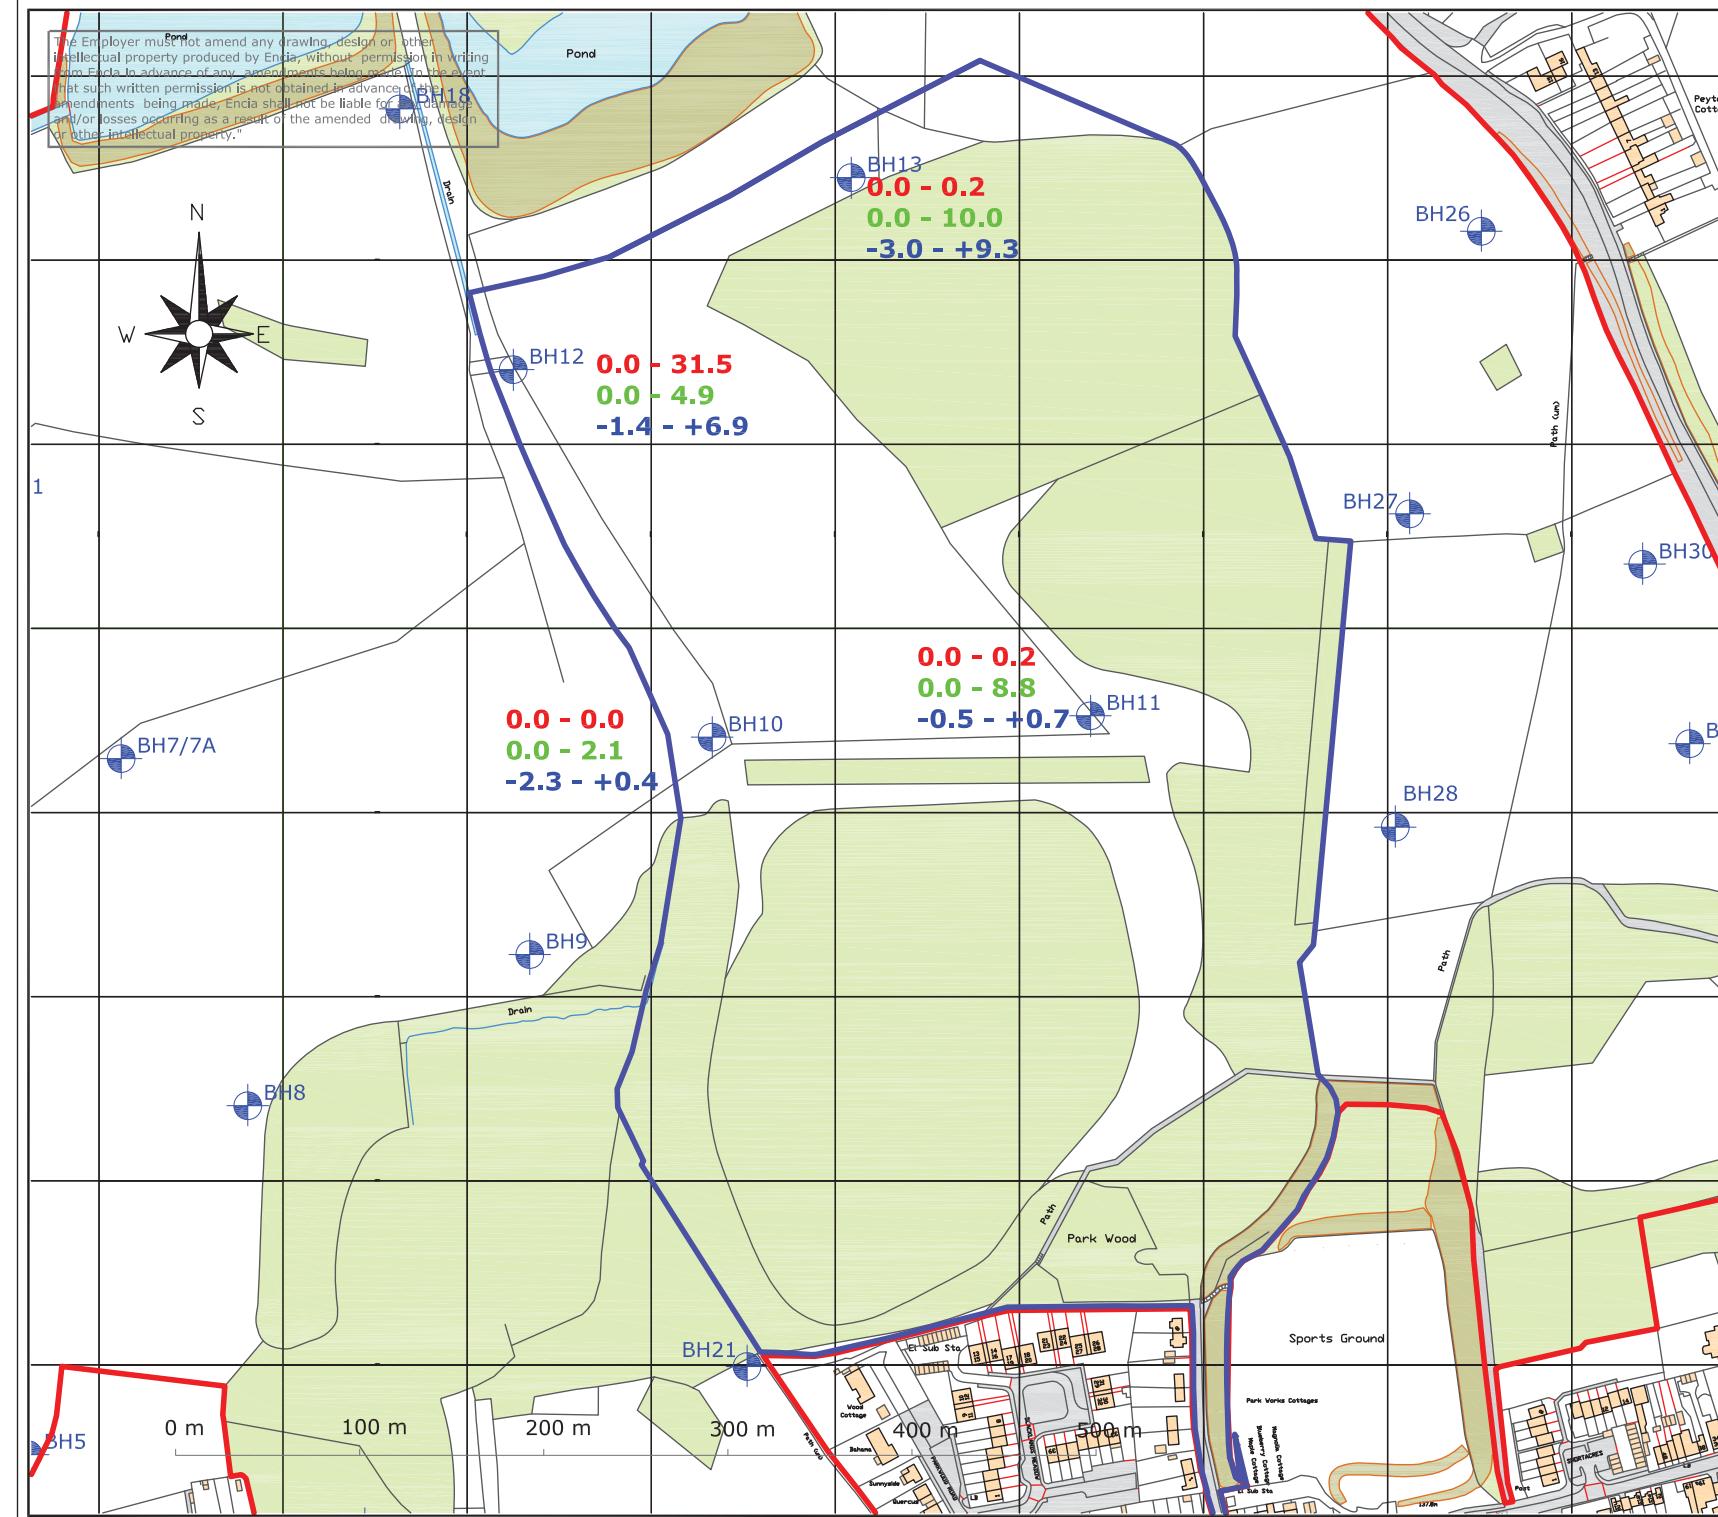
1:3000@A3 DRG No. 20096-E-12

CH4 (%v/v) **CO2 (%v/v)** **Flow (l/hr)** October 2011-March 2013

LANDFILL GAS CONCENTRATIONS - BEECHFIELD QUARRY

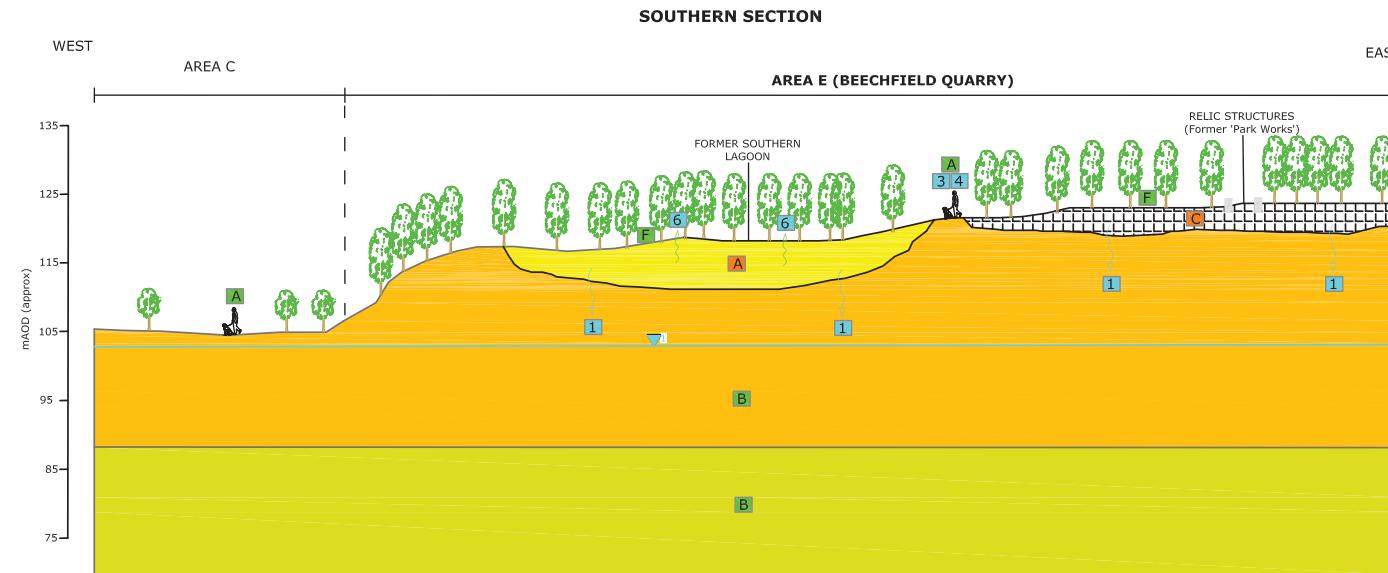
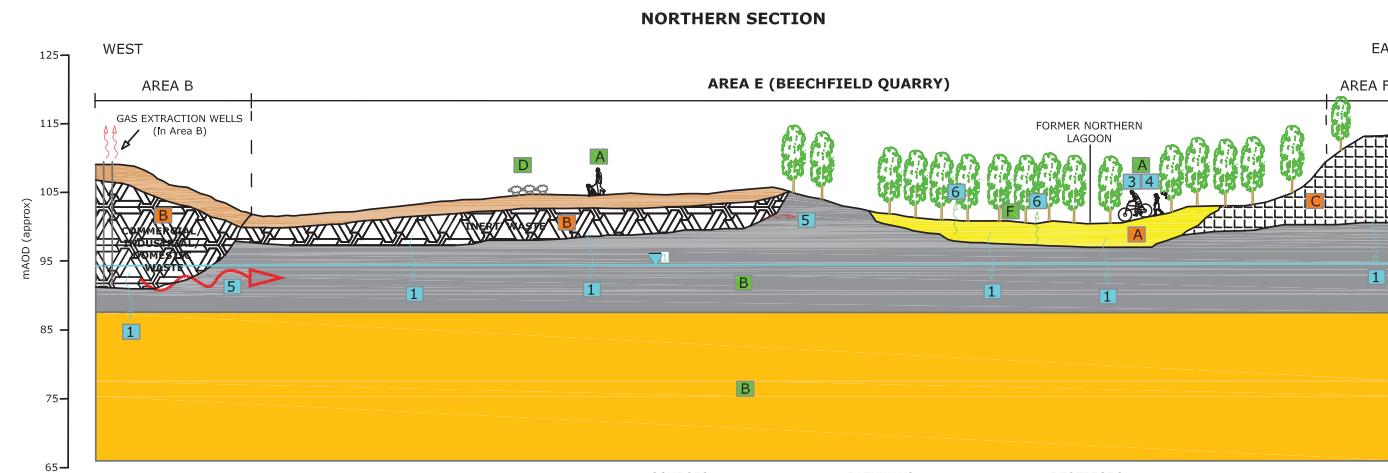
- RESTORATION SOILS/CAP
- WASTE
- MADE GROUND (Reworked Natural)
- MADE GROUND (Yellow Lagoon Silt)
- FOLKESTONE BEDS
- SANDGATE BEDS
- HYTHE BEDS
- GROUNDWATER
- SURFACE WATER

- LAGOON SILTS - Arsenic, SO₄
- WASTES
- MADE GROUND - Reworked natural strata (Arsenic, BaP)
- LEACHING/MIGRATION TO GROUNDWATER
- GROUNDWATER MIGRATION
- INJECTION/DERMAL CONTACT
- INHALATION
- HAZARDOUS GAS MIGRATION
- VEGETATION UPTAKE

- SITE USERS (Walkers/cyclists)
- CONTROLLED WATERS (Sandgate Beds Secondary 'A' and Folkestone/Hythe Bed Principal Aquifers)
- CONTROLLED WATERS (Surface Waters - Angling Ponds and Country Park)
- LIVESTOCK
- SITE USERS (Anglers)
- AQUATIC/WOODLAND ECOSYSTEMS

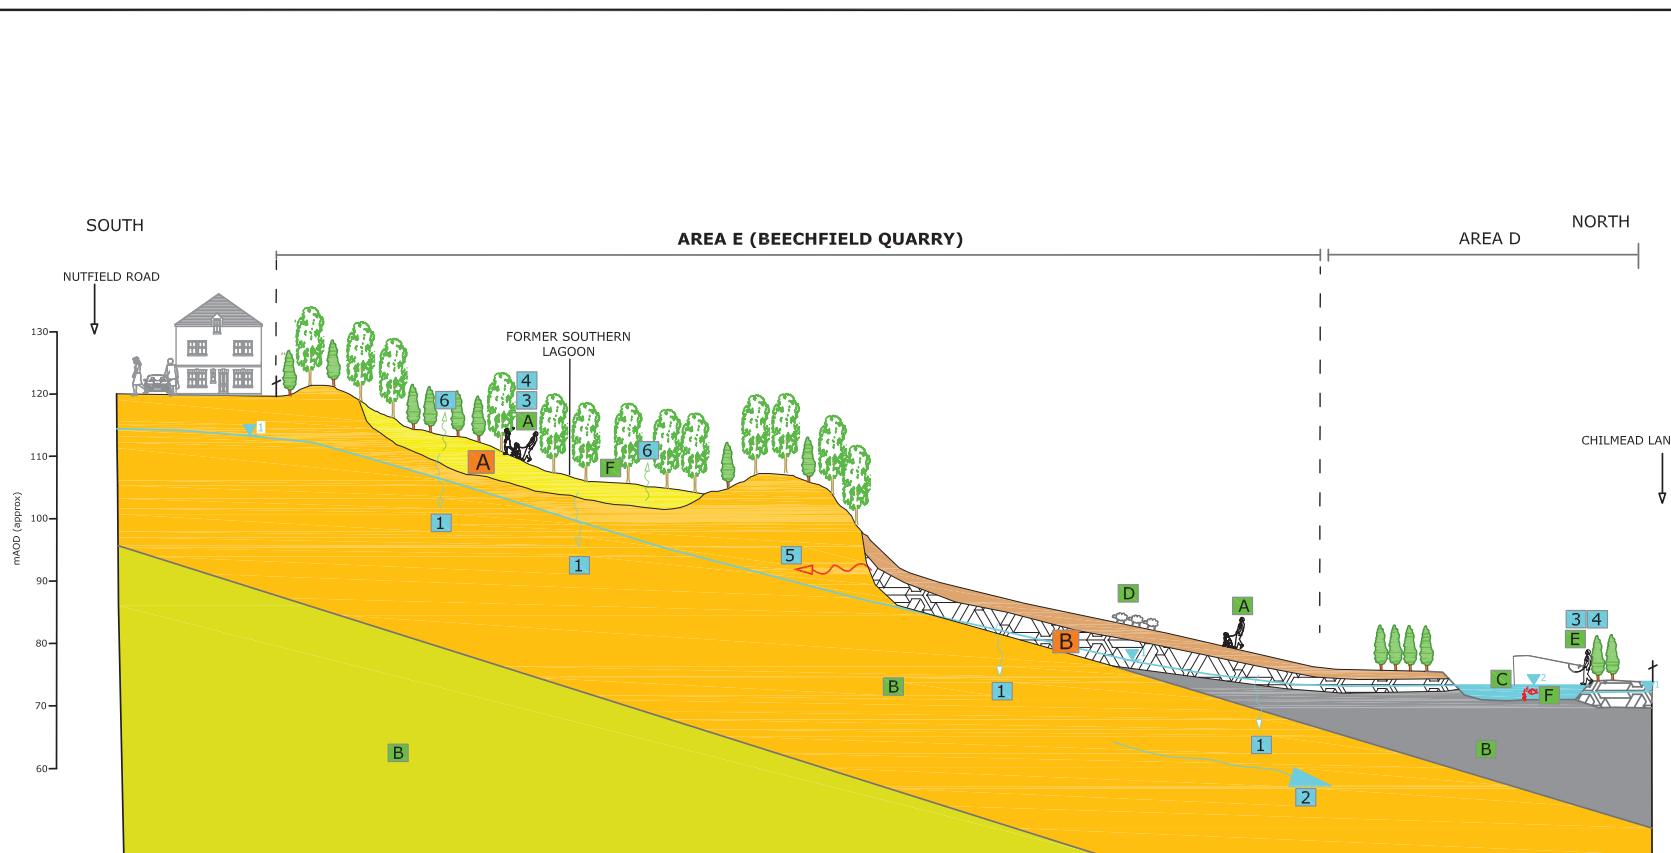
DRAWN BY	SIGNATURE	DATE
AJA		29/05/2013
APPROVED	SIGNATURE	DATE
KL	29/05/2013	
SCALE	NOT TO SCALE	
DRG No.	20096-E-13B

**CONCEPTUAL SITE
MODEL - BEECHFIELD
QUARRY (N-S SECTION)**

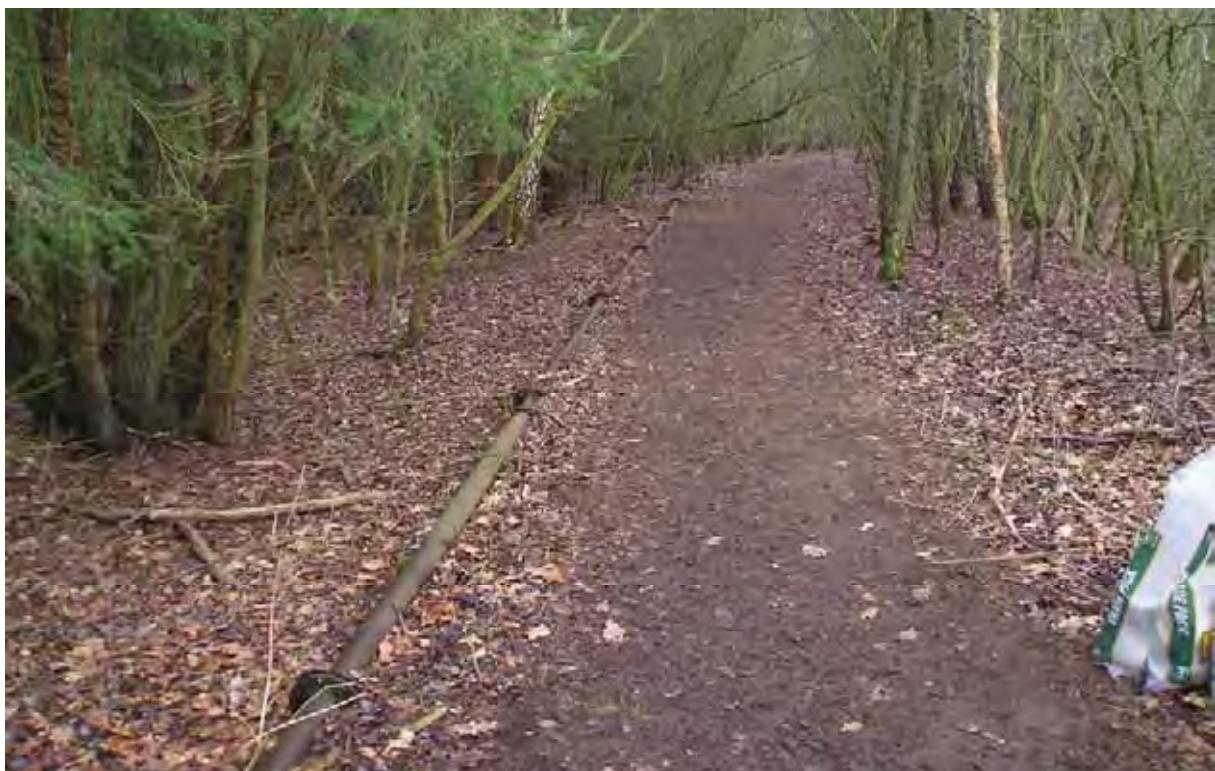
Photograph E2 – Relic pipework adjacent to footpath at south-western edge of Beechfield Quarry

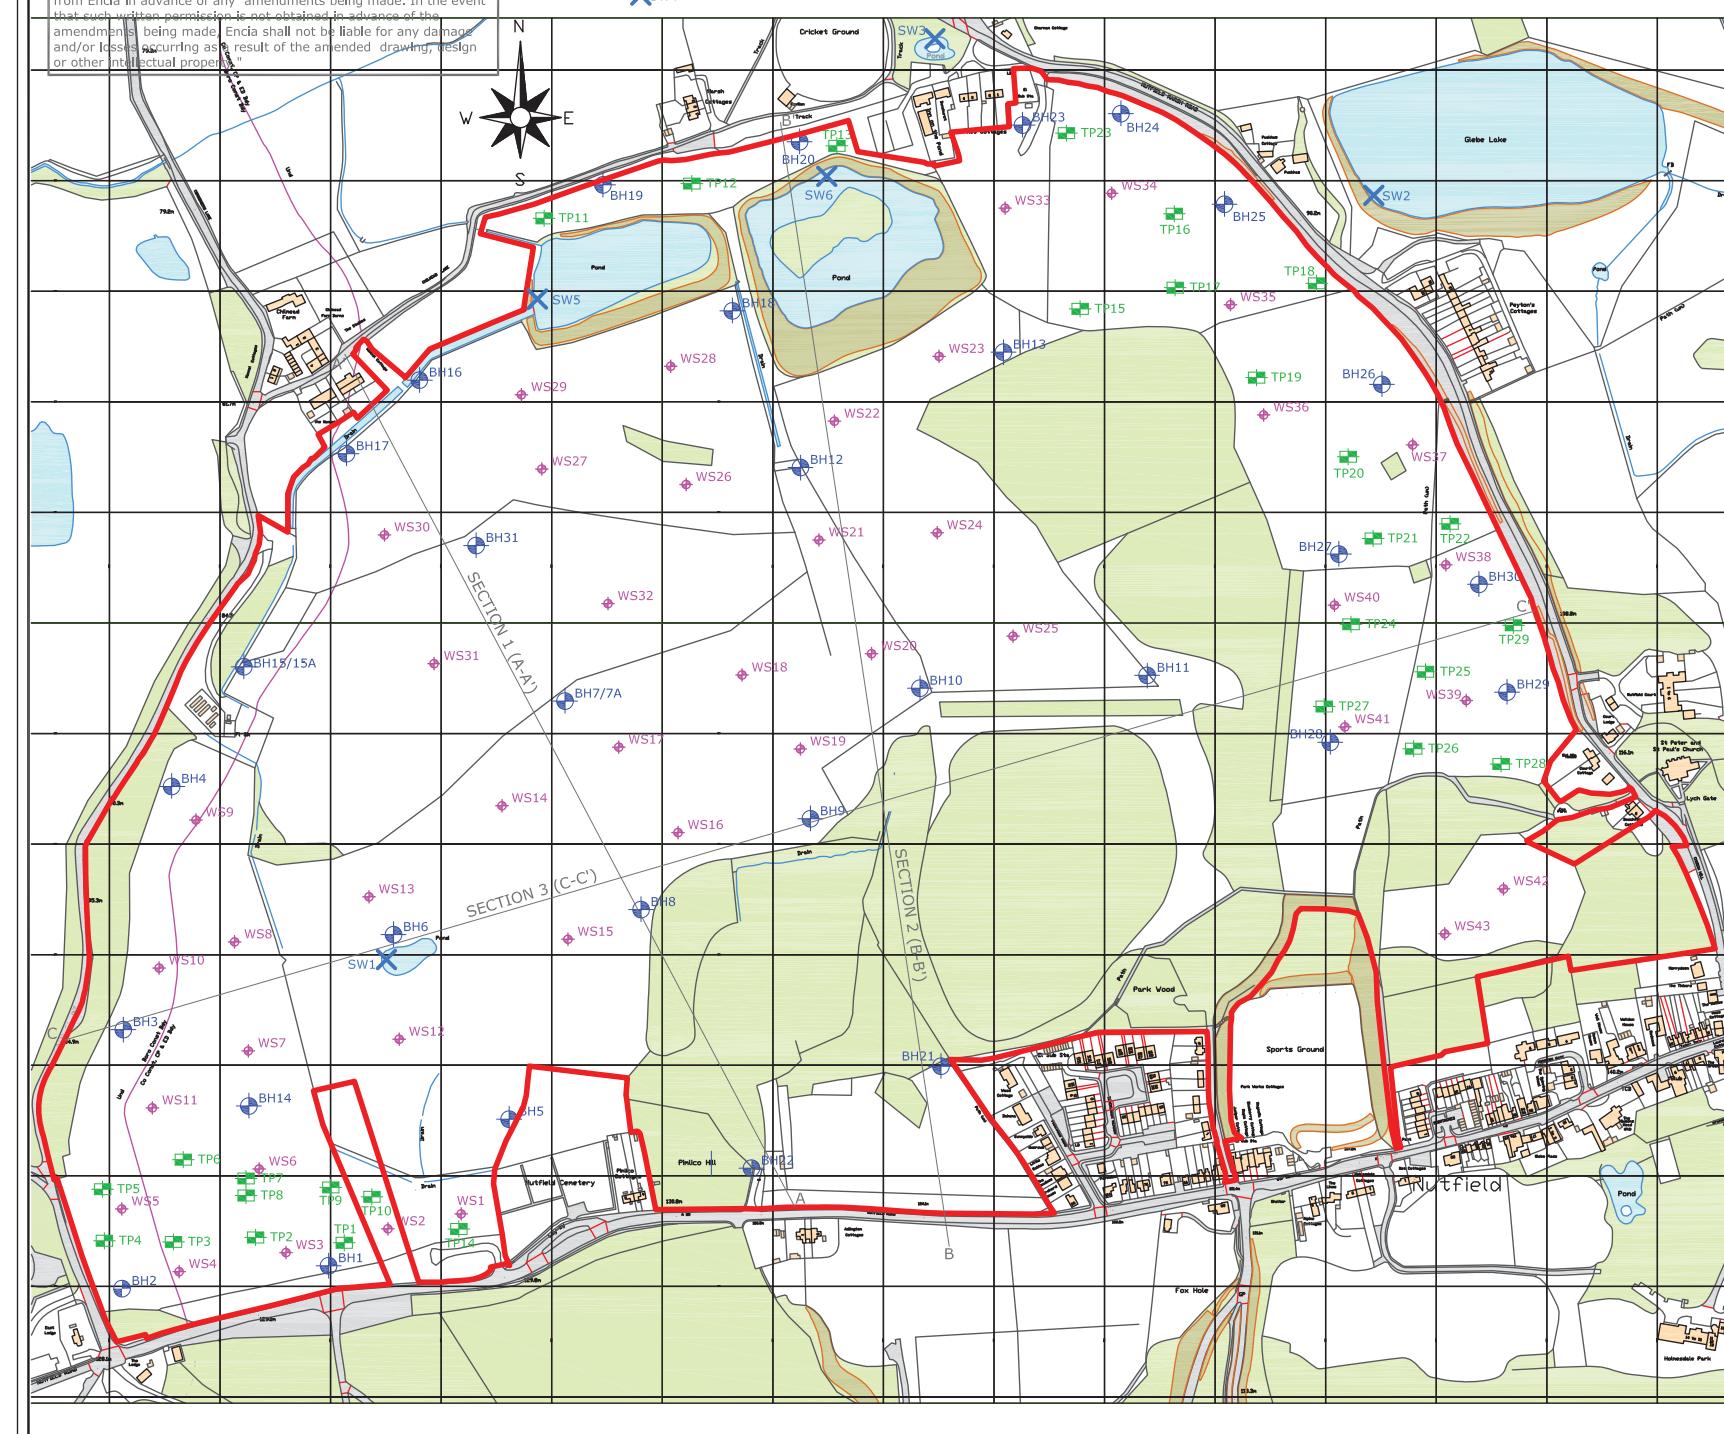
20096-9-REVA

- SITE BOUNDARY** (Red line)
- ENCIA TRIAL PIT (2011)** (Green square)
- ENCIA BOREHOLE (2011)** (Blue circle)
- ENCIA WINDOW SAMPLE (2011)** (Pink diamond)
- SURFACE WATER SAMPLE POINT** (Blue cross)

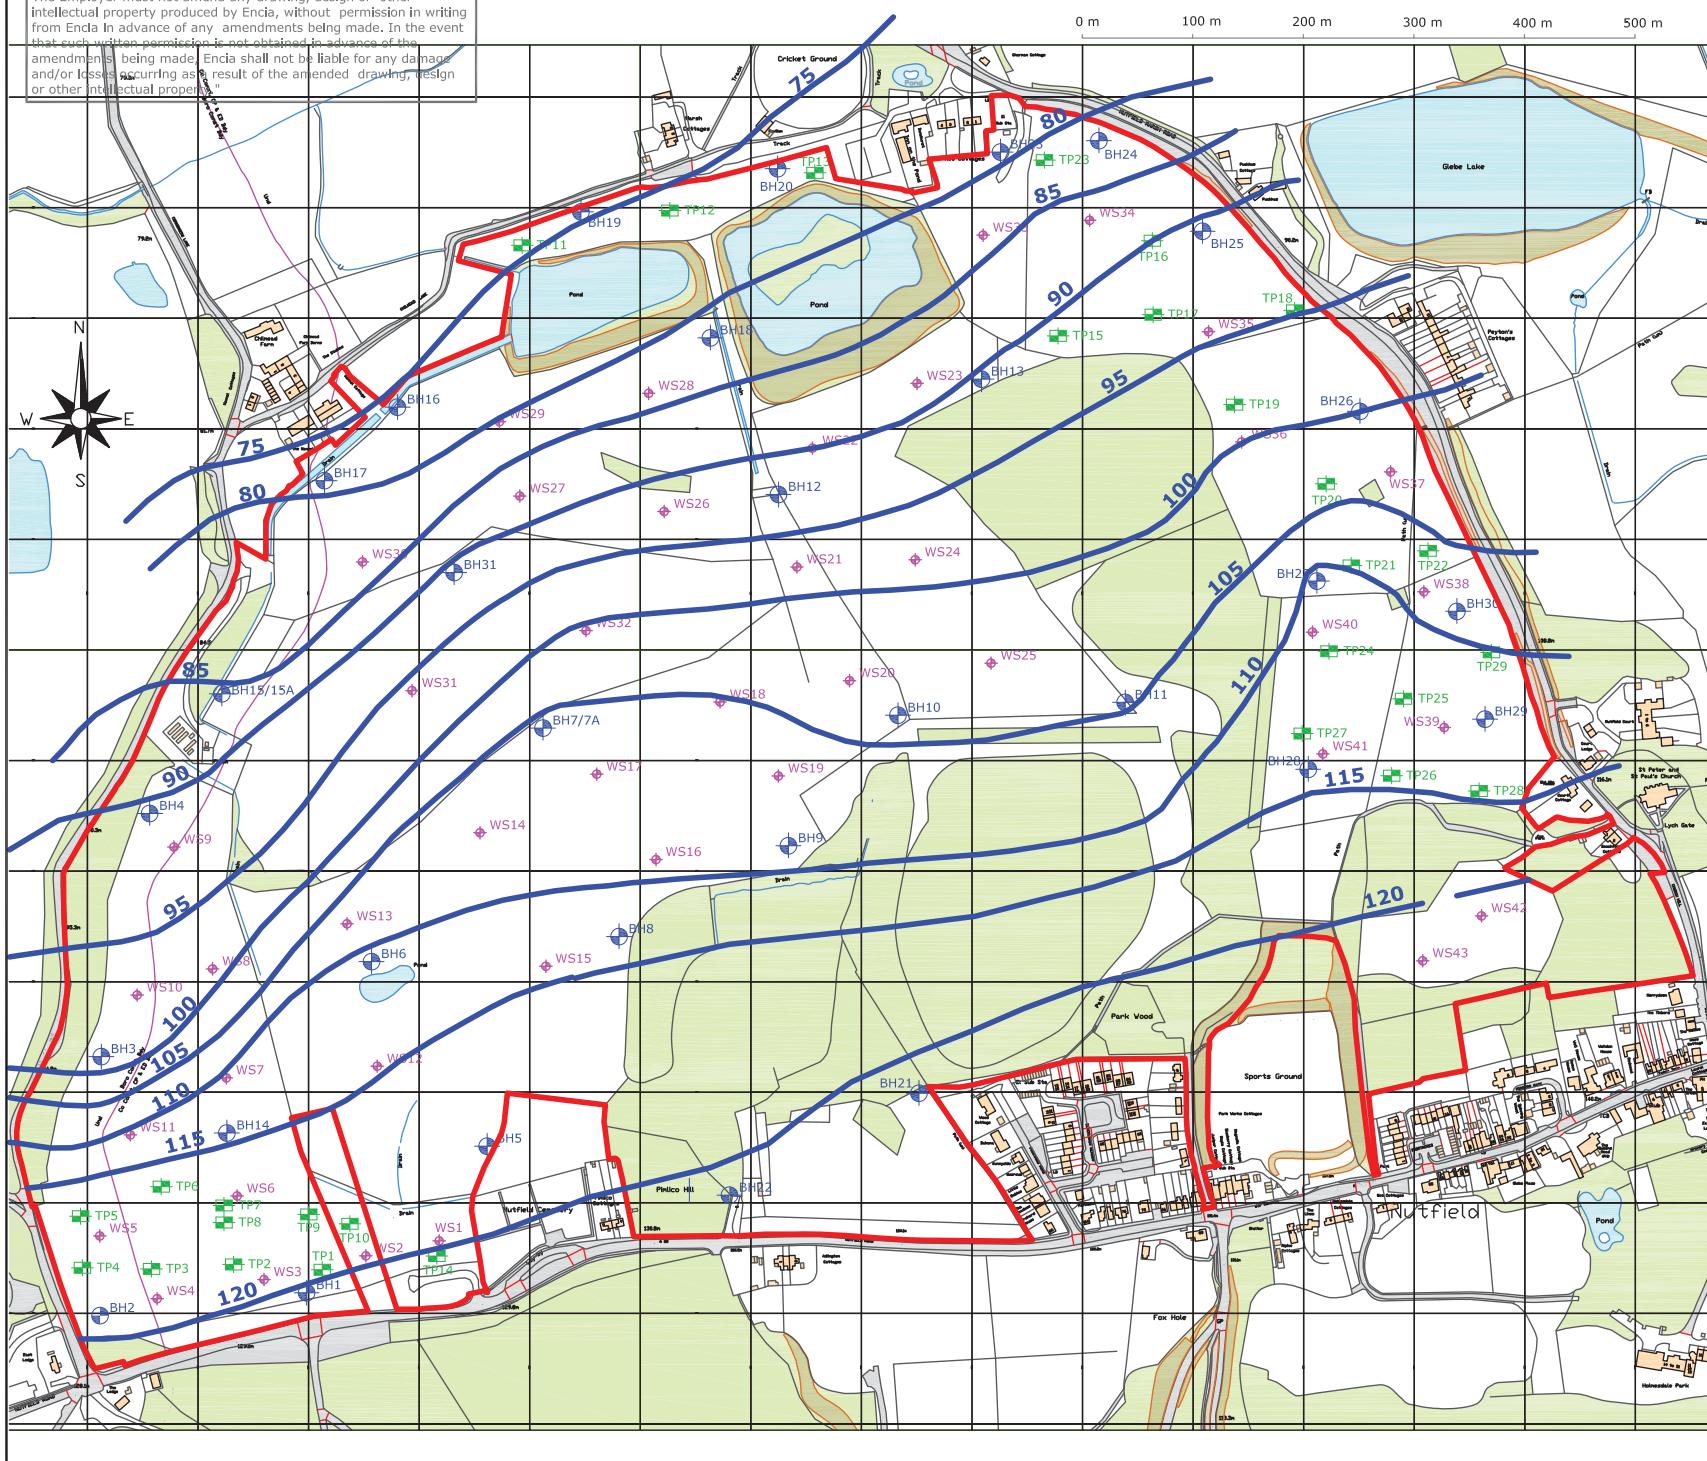
20096-13A

The previous (late 2011) ground investigation identified a relatively regular pattern of groundwater flow across the site. **Drawing No. 20096/13A in Appendix A** presents approximate groundwater contours (in mAOD) as observed in November 2011.

Groundwater levels were in the order of 120-122mAOD in the south of the site and which decreased in a northerly direction to ca. 75mAOD in the vicinity of Chlimead Lane in the north. The approximate hydraulic gradient across the site was observed to be relatively steep and was calculated to be approximately 0.053m/m.
