EVONIK DEGUSSA  
UK HOLDINGS LTD

FORMER LANDFILL & QUARRIES,  
REDHILL, SURREY

CONCEPTUAL SITE  
MODEL - CHURCH HILL  
AREA

### **Exploratory Hole Records (Church Hill Area)**

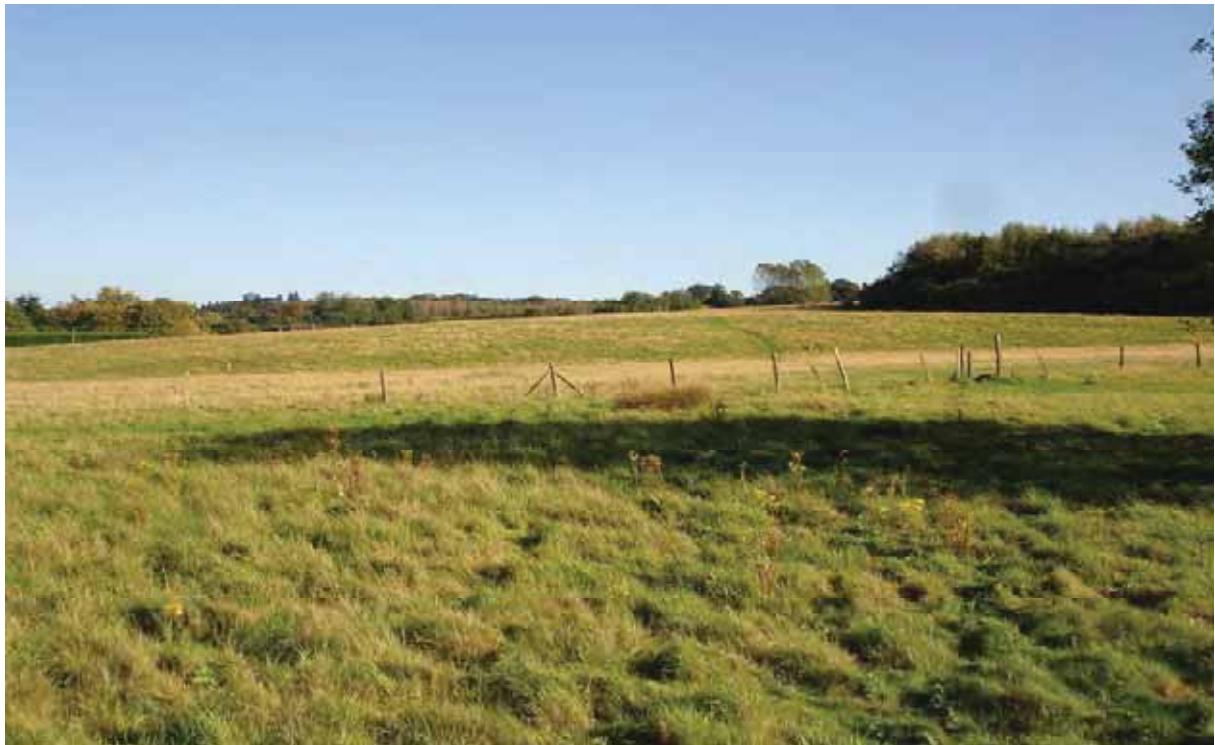
**Photograph 24** – View looking southeast from the northeastern corner of the study site across the former Church Hill area. Note the break of slope in the centre of the image which suggests infilling to the south of this slope.
