SITE Former Landfills, Nutfield Road, Redhill

Appendix F
Former Landfills, Nutfield Road, Redhill, Surrey
Summary of Groundwater Level Measurements

Statistical Analysis of Soil Chemical Test Results
Gore Meadow Area

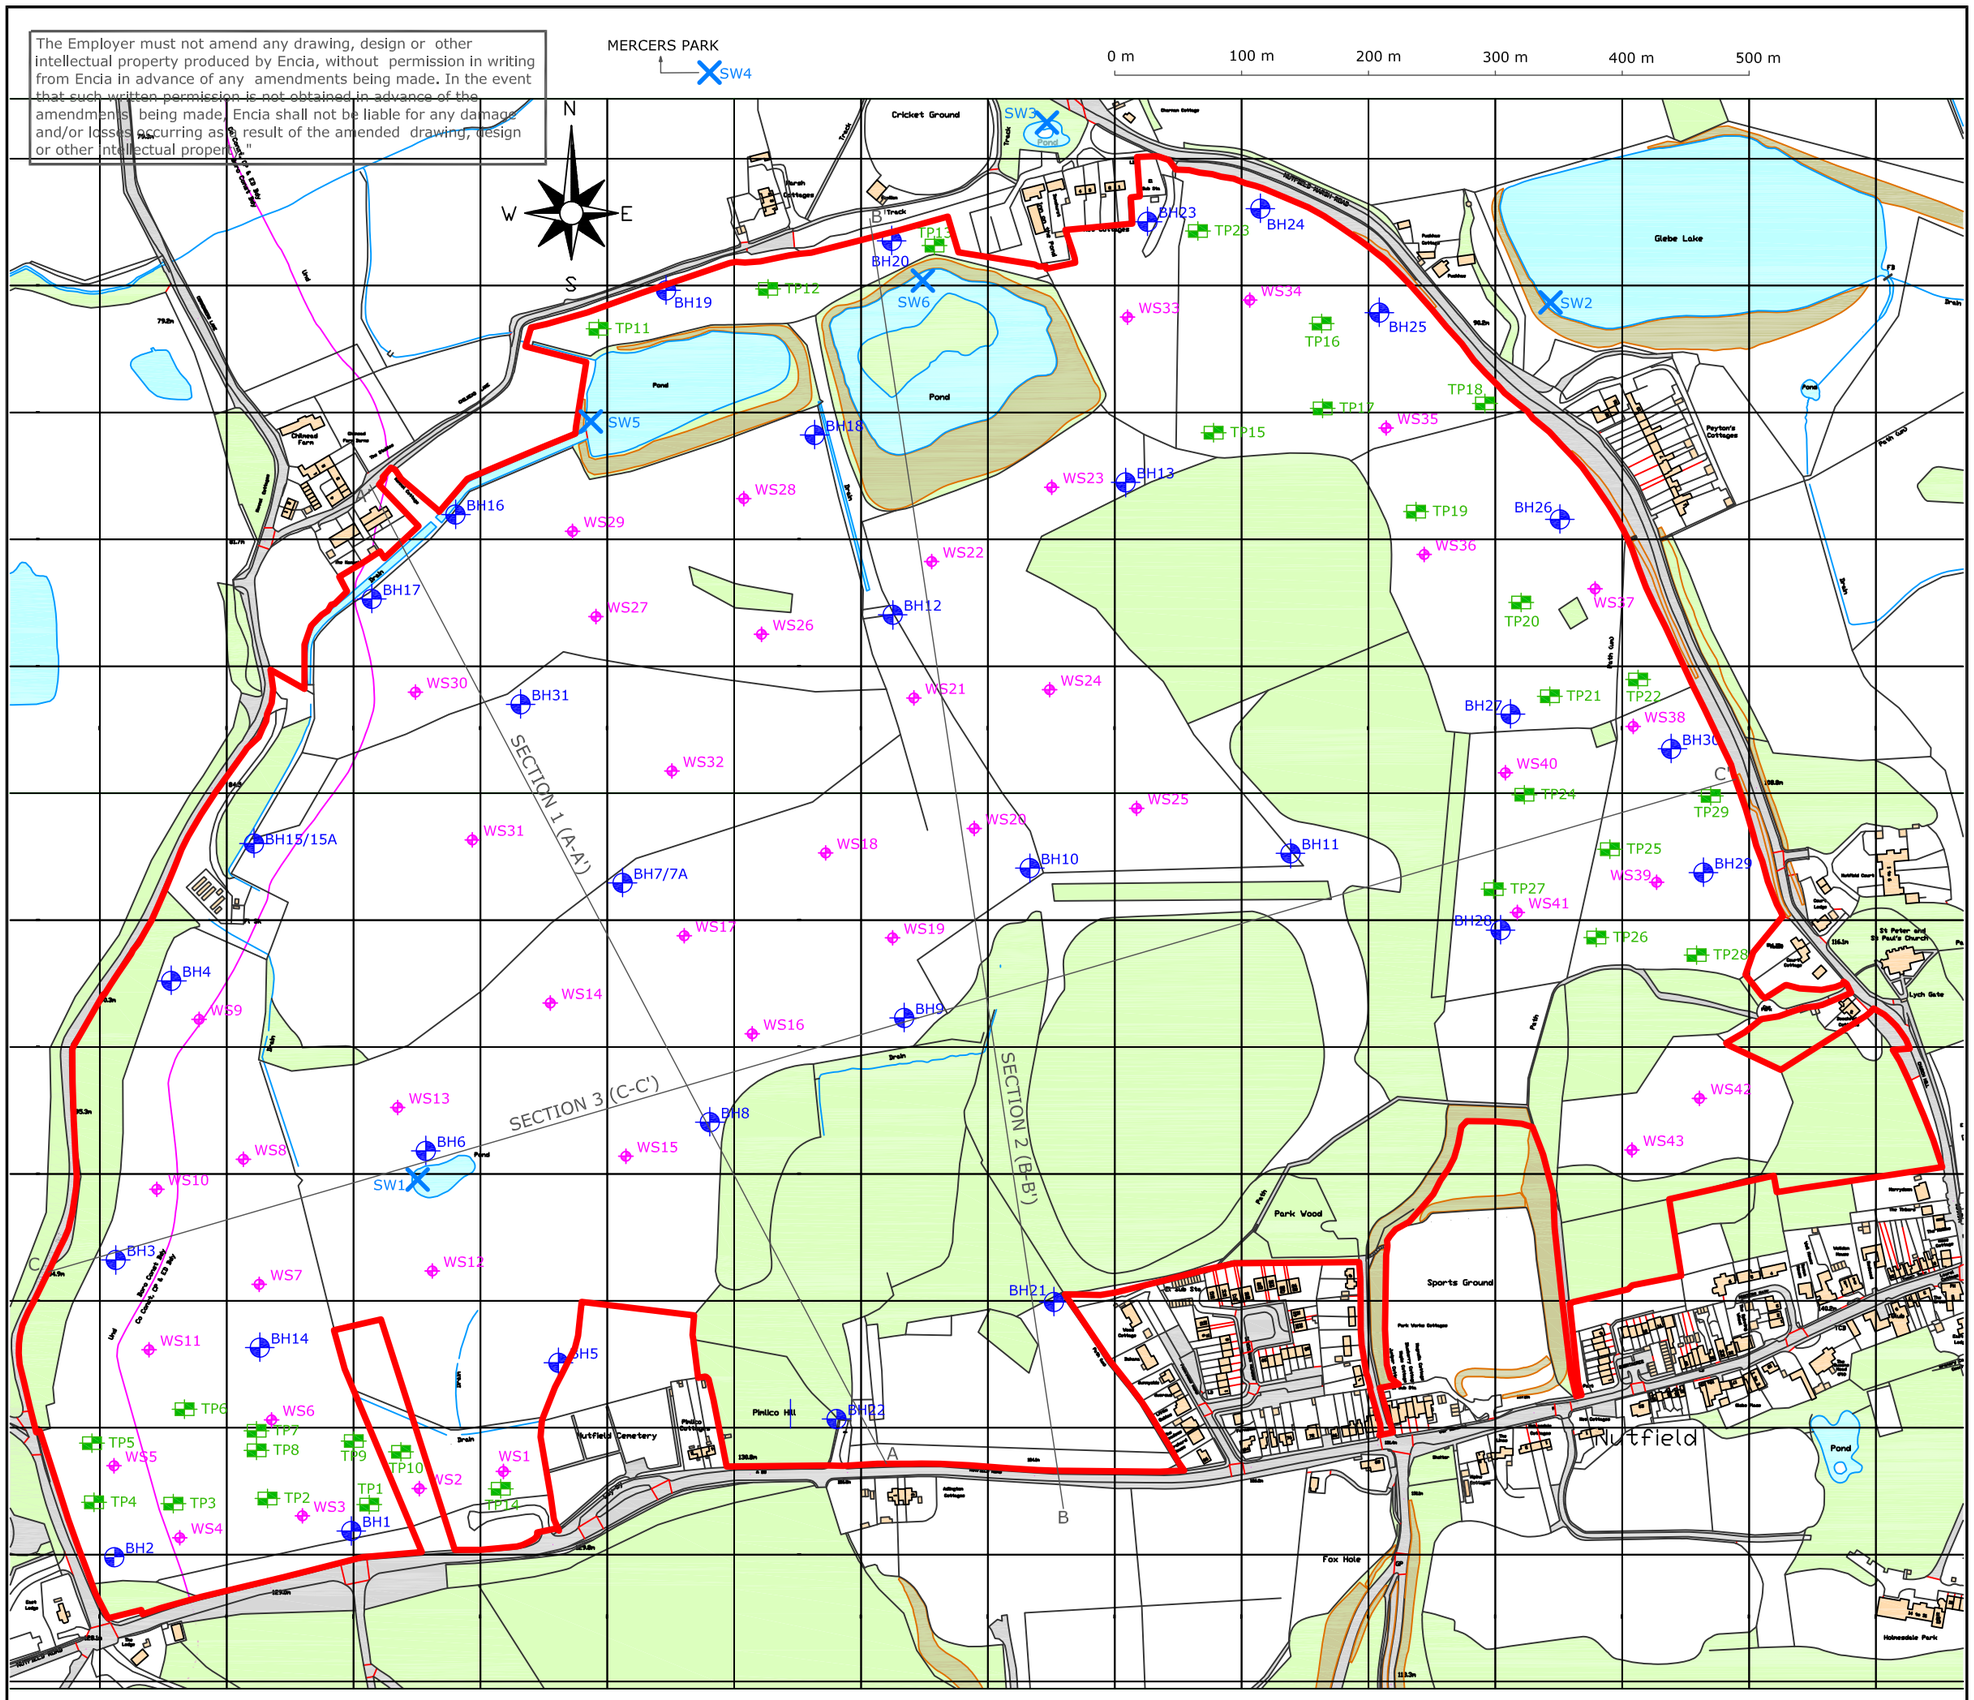
STATUS		
FINAL		
DRAWN BY: KL	SIGNATURE	DATE: 15/11/2011
APPROVED: AJA	SIGNATURE	DATE: 15/11/2011
SCALE: 1:5000@A3	DRG No.: 20096-13A

The previous (late 2011) ground investigation identified a relatively regular pattern of groundwater flow across the site. **Drawing No. 20096/13A in Appendix A** presents approximate groundwater contours (in mAOD) as observed in November 2011.

Groundwater levels were in the order of 120-122mAOD in the south of the site and which decreased in a northerly direction to ca. 75mAOD in the vicinity of Chlimead Lane in the north. The approximate hydraulic gradient across the site was observed to be relatively steep and was calculated to be approximately 0.053m/m.

APPROXIMATE GROUNDWATER CONTOURS (NOVEMBER 2011)
