**ENCIA 2013. SUMMARY ENVIRONMENTAL RISK REPORT OF CHURCH HILL (AREA F), NUTFIELD ROAD, REDHILL, SURREY. PREPARED FOR EVONIK DEGUSSA UK HOLDINGS LIMITED REPORT NUMBER 20096/6F, MAY 2013**

**SUMMARY ENVIRONMENTAL RISK REPORT  
of  
CHURCH HILL ('AREA F')  
NUTFIELD ROAD, REDHILL, SURREY**

**SUMMARY OF GEOENVIRONMENTAL RISKS**  
**CHURCH HILL (AREA F)**  
**NUTFIELD ROAD, REDHILL, SURREY**

This present report is therefore intended to present an overview and summary of the findings of the geoenvironmental investigations carried out in the **Church Hill** part of the site (referred to in previous Landplus/Encia reports as '**Area F**').

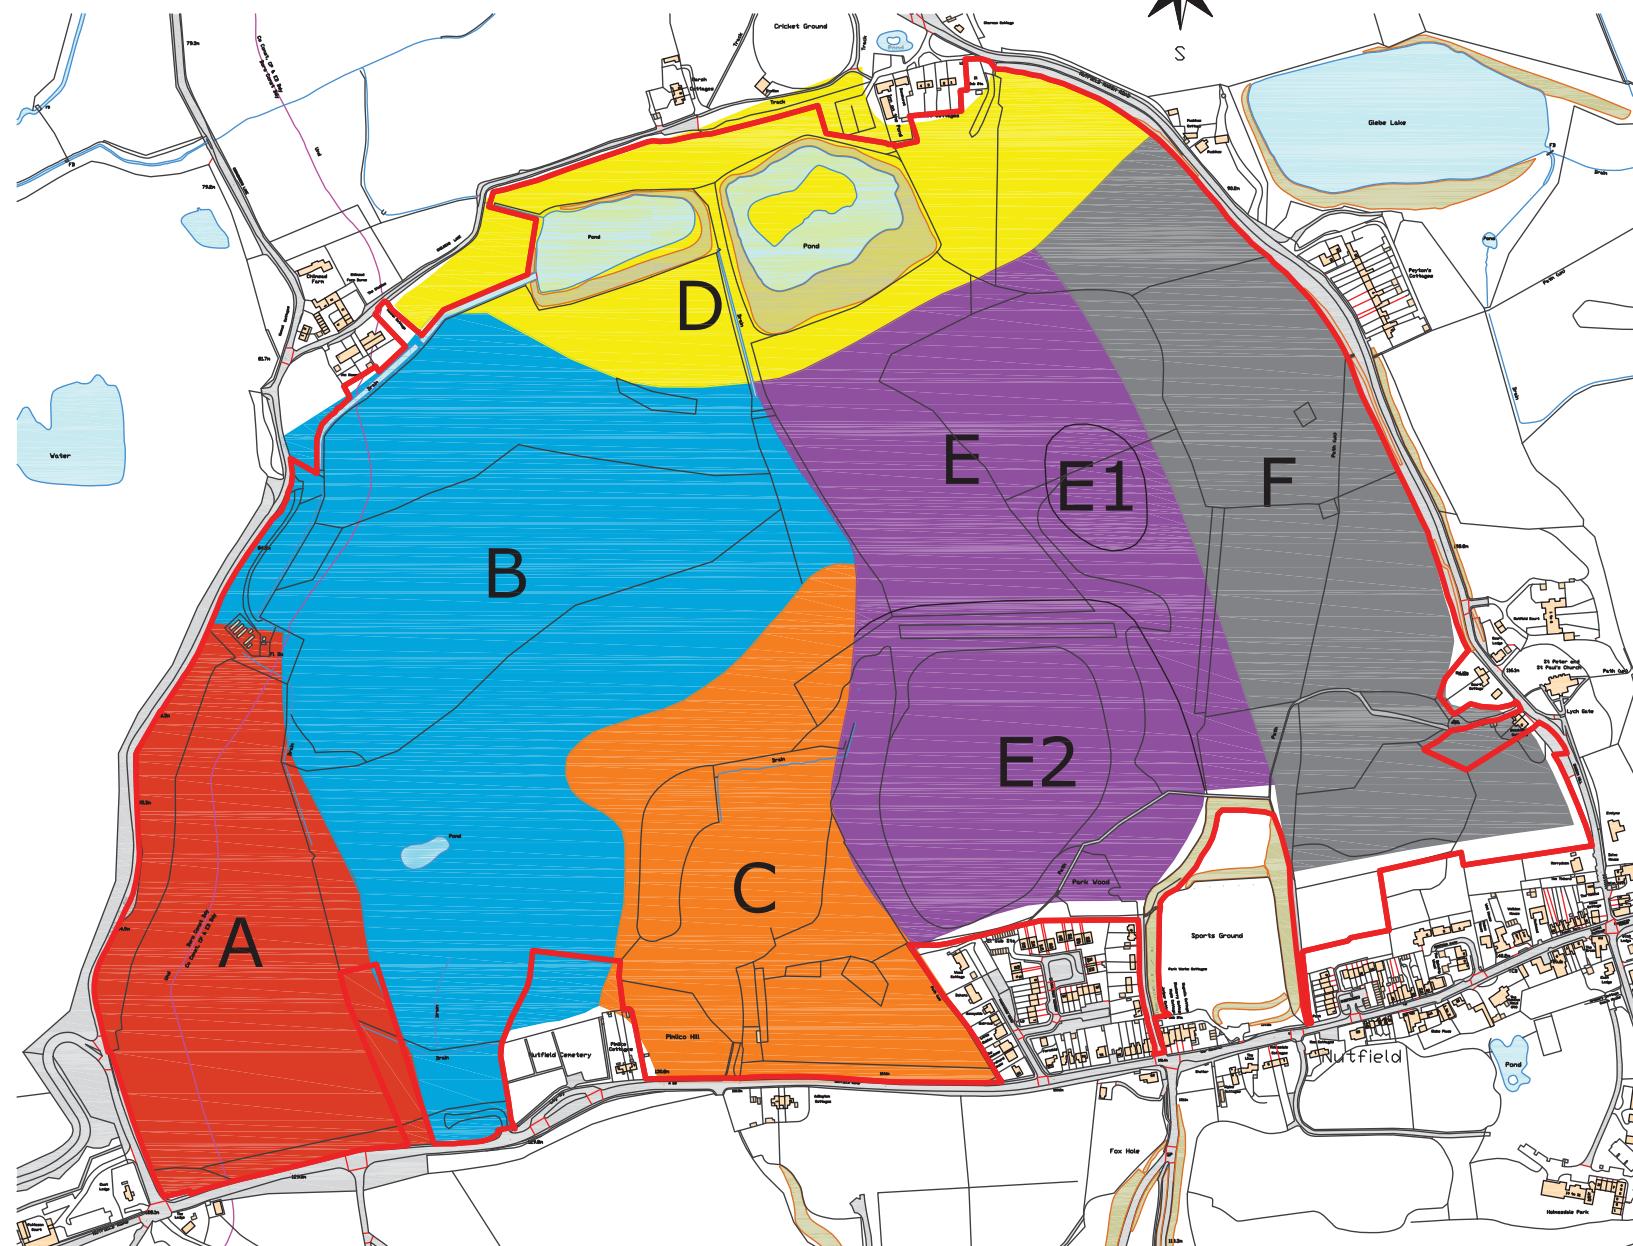
- A PARK QUARRY
- B NORTH COCKLEY
- C GORE MEADOW
- D SAND PIT
- E BEECHFIELD QUARRY
- F CHURCH HILL

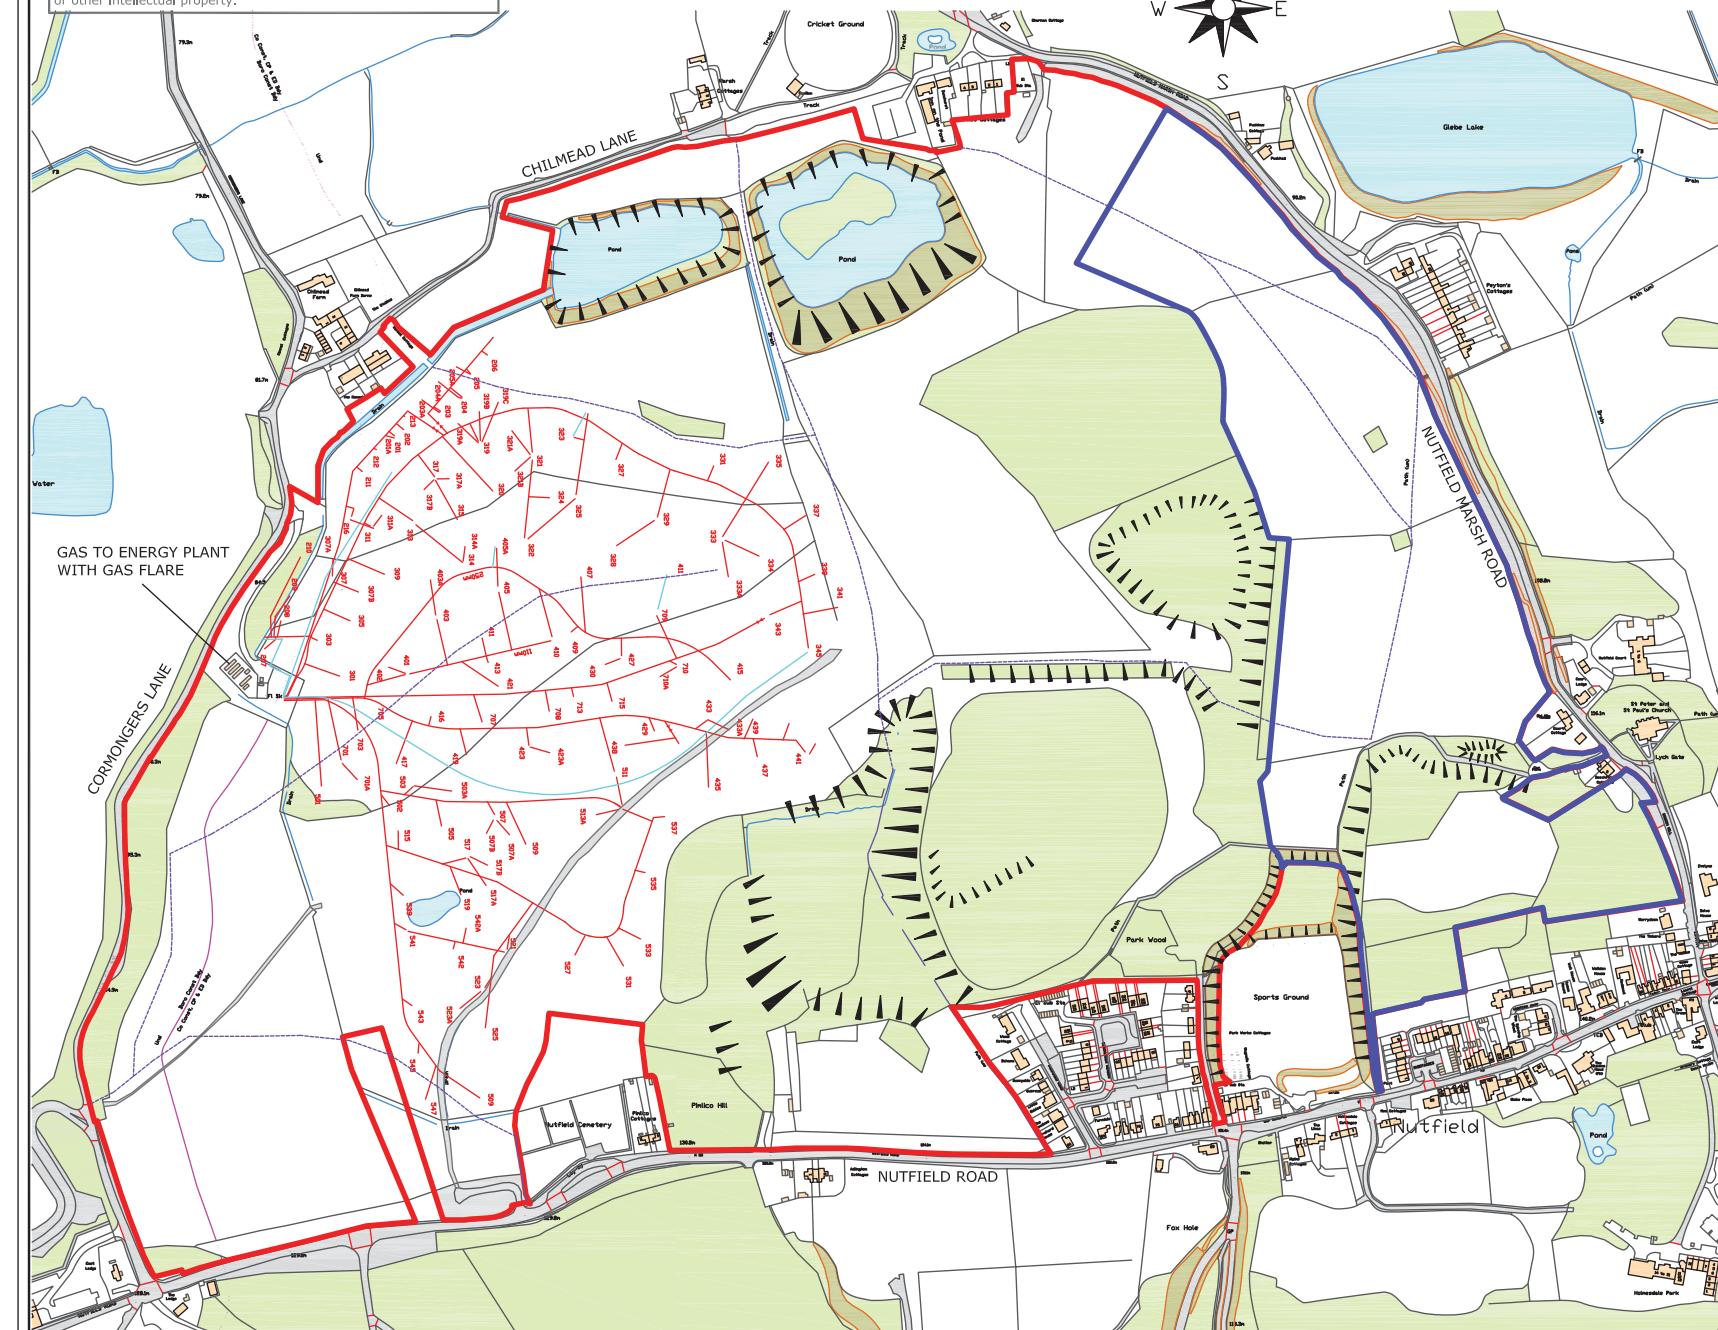
- WOODLAND
- SURFACE WATER
- HARDSTANDING
- GAS EXTRACTION PIPELINE & WELL
- PUBLIC FOOTPATH
- CHURCH HILL AREA BOUNDARY
- STEEP SLOPE

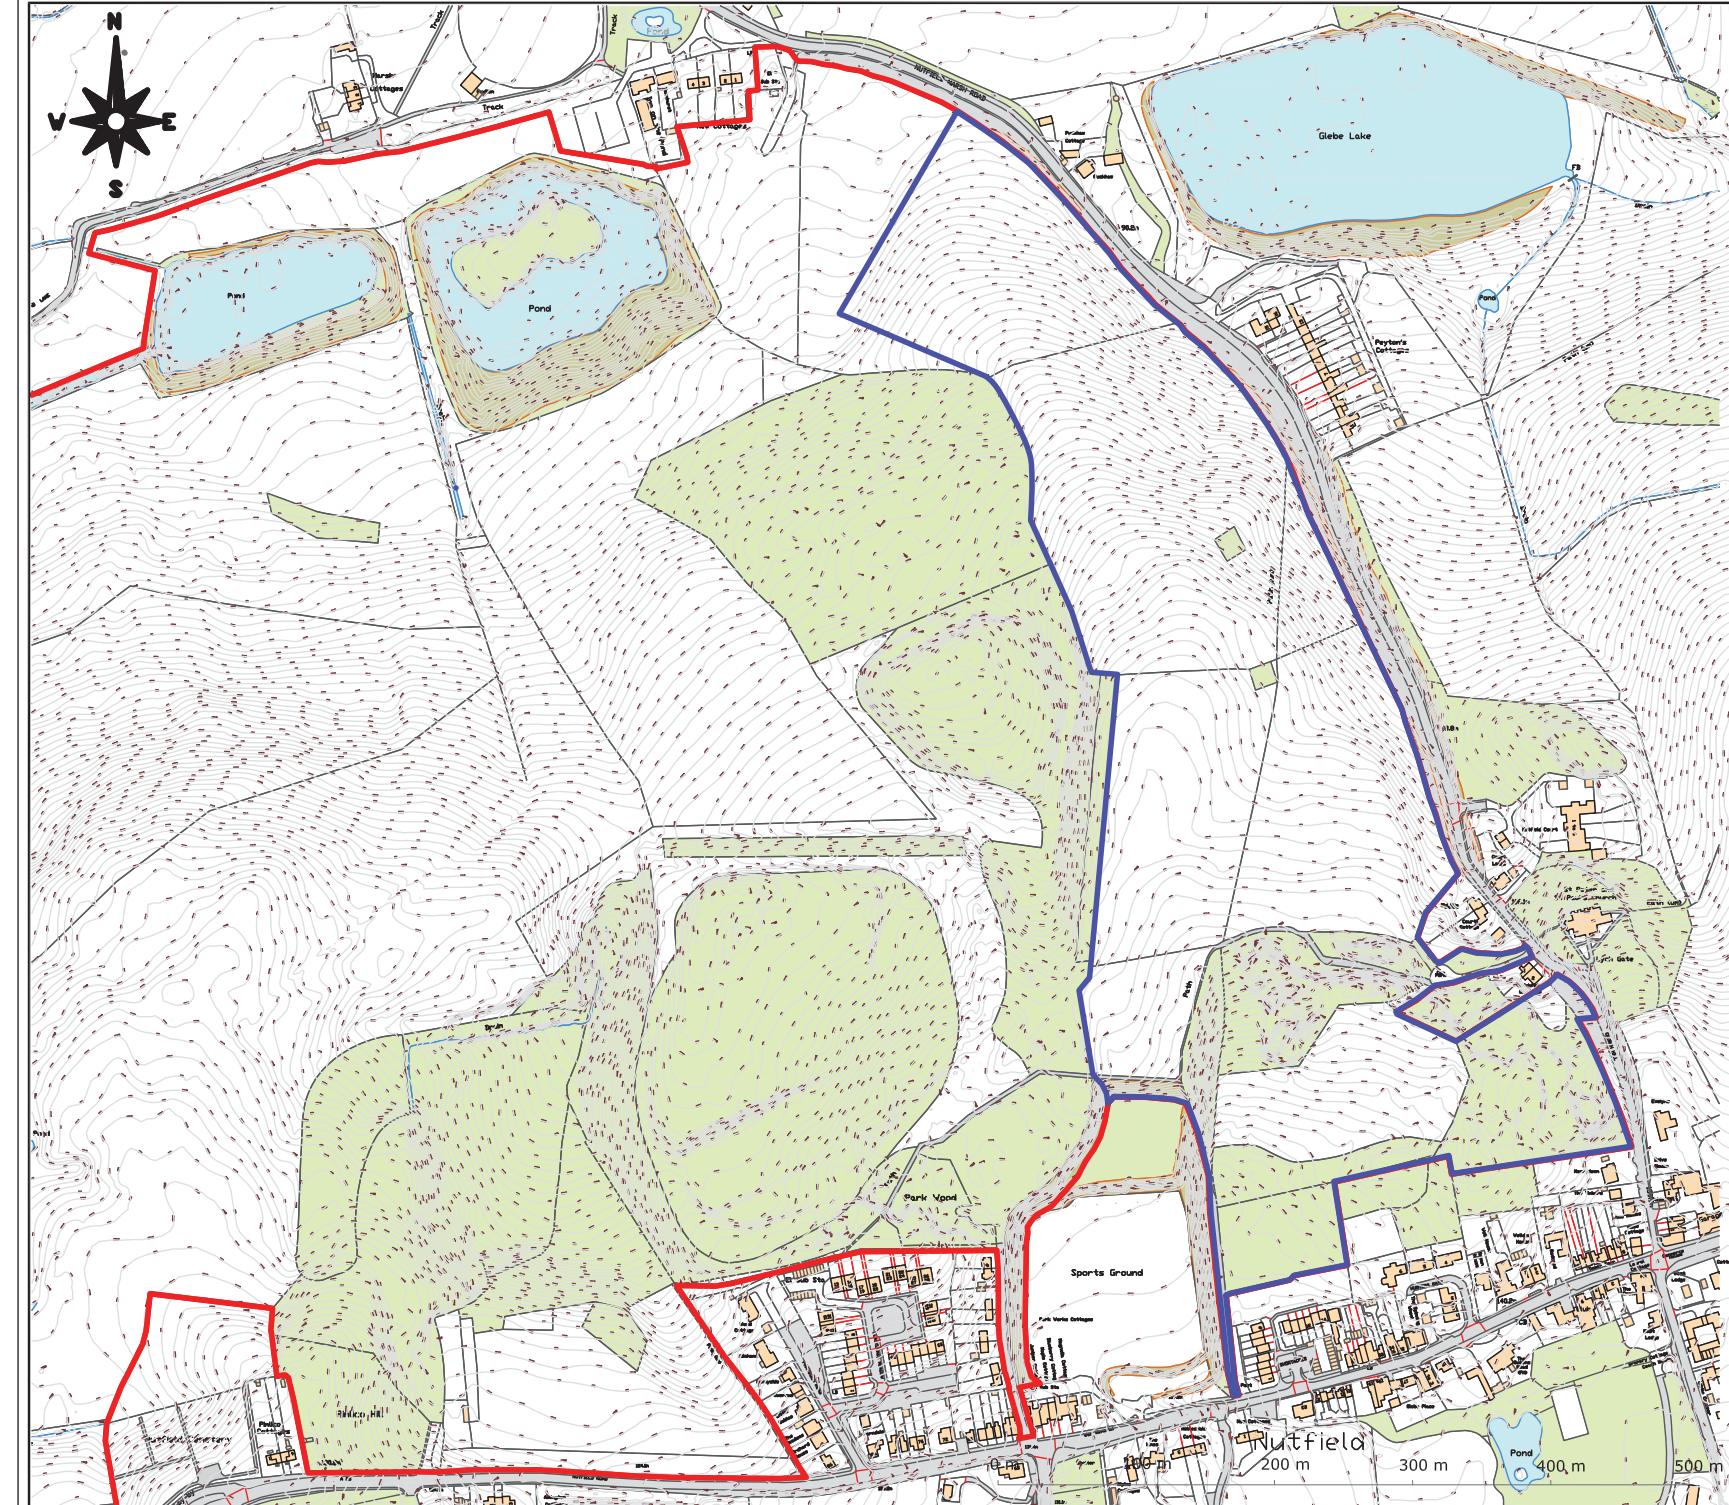
20096-3

SURVEY INFORMATION BASED ON AN ENVIRONMENT AGENCY  
REMOTE LIGHT DETECTION AND RANGING (LIDAR) SURVEY

SURVEY DATE UNKNOWN
